Condensing Rooftop Unit Field Study Final Report

7/24/2019

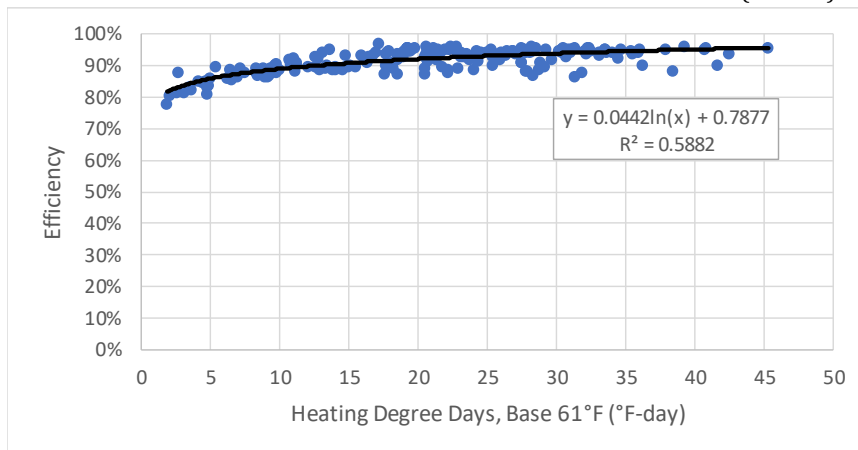
FIGURE 10 – DAILY EFFICIENCY VS. HEATING DEGREE DAYS (SITE A)

Similarly, we calculate the daily efficiency relationship to heating degree days. Figure 10 shows an example relationship plotting Site A’s daily heating efficiency compared to the daily HDD_61. Efficiency is relatively flat at this site except for the warmer days (lower HDDs). On these warmer days, the burner has very few run-hours and cycles more often than on colder days despite the C-RTU’s high turndown (35:1). The higher cycle rate results in some inefficiencies as the burner goes through a purge sequence before running the burner. However, this inefficiency has very little effect on the annual performance as a majority of the heating load occurs on higher HDD days and the annual performance is significantly weighted toward these higher efficiency days.

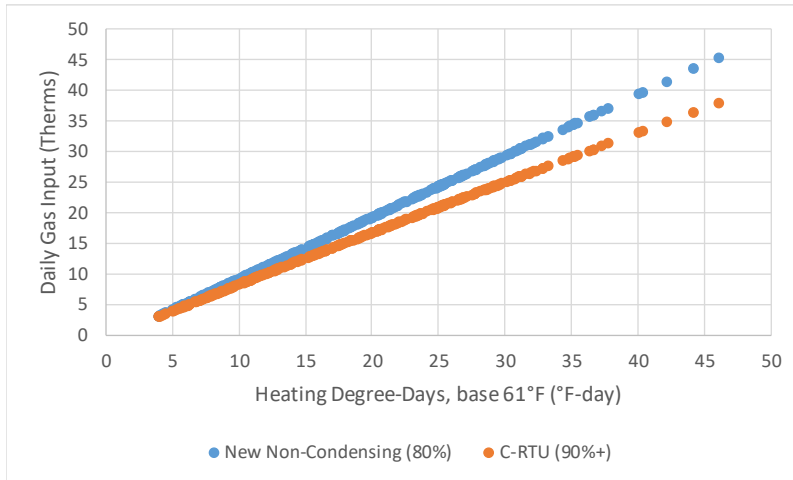
FIGURE 12 – MODELED DAILY GAS INPUT (SITE A)

We then calculate the daily C-RTU gas energy consumption by dividing the daily heating load (shown in Figure 11) by the daily efficiency (determined by the daily total HDD and daily efficiency regression equation shown in Figure 10). Equation 4.4 provides the general equation we used to determine gas input.

$$[Eq\ 4.4]\ Gas\ input\ (therms) = \frac{Heating\ load\ (therm_{eq})}{Efficiency_{C-RTU,Daily}}$$

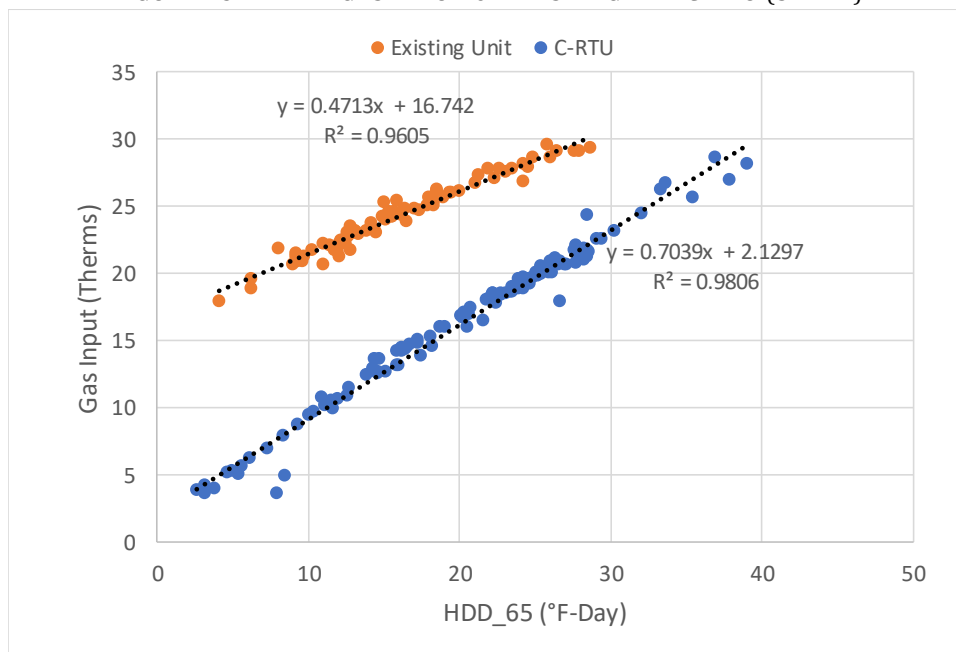
FIGURE 13 - DAILY GAS INPUT OF EXISTING AND C-RTU (SITE D)

The one site for which we were able to collect significant cold weather data for the baseline unit was Site D. Figure 13 compares the daily RTU gas input for the existing unit from 10/2/2018 through 12/18/2018 and the replacement C-RTU from 12/21/2018 through 3/31/2019. While this figure clearly shows the gas savings between the two units on similar weather days, using these results to compare savings would not be a fair comparison. The baseline unit provided roughly 1,550 cfm of outside air at 85°F (unit originally designed at 1,670 cfm and 68°F). The new C-RTU now delivers 1,833 cfm on average and the maintenance manager elected to change the discharge air temperature setpoint to 75°F based on recent feedback from residents. These differences in pre- and post-replacement are typical across the four sites; for this reason, we calculate the energy savings based on holding the delivered heating load measured during the post-installation period constant as described in this section rather than making a direct comparison. In addition, since we selected and installed two of the sites during the summer of 2018, we have little gas consumption data on the existing Site A and B units.

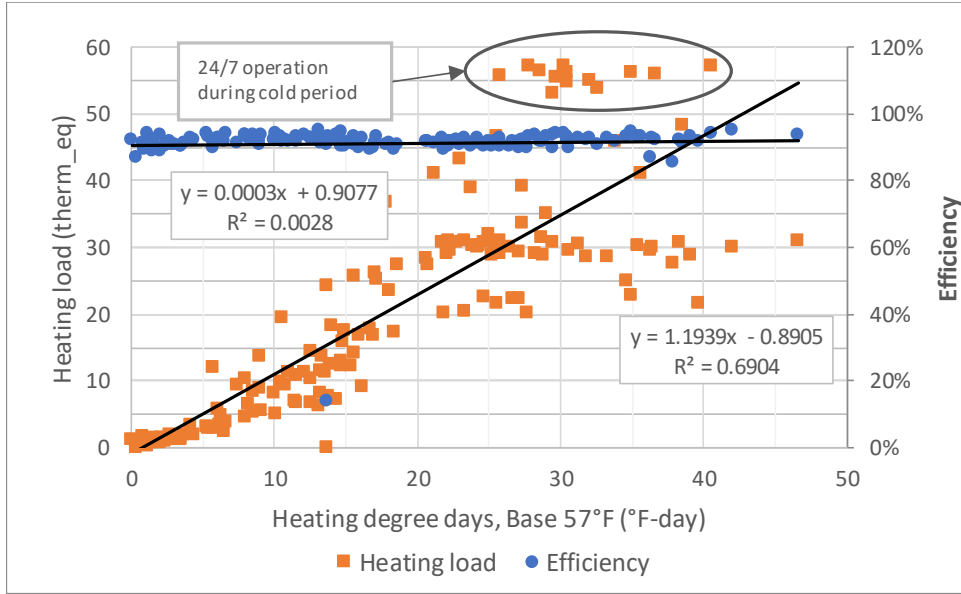
FIGURE 15 - SITE B DAILY HEATING LOAD & EFFICIENCY

The heating load regression is not nearly as strongly correlated with HDD for Site B as for the other sites due to varying operational schedules. The facility manager is quite active and often changes the HVAC equipment schedule depending on weather and school events. For example, the outliers highlighted in Figure 15 all occur during two of the coldest weeks in the winter of 2018/2019 when the C-RTU ran 24 hours per day to ensure the faculty offices were sufficiently conditioned.

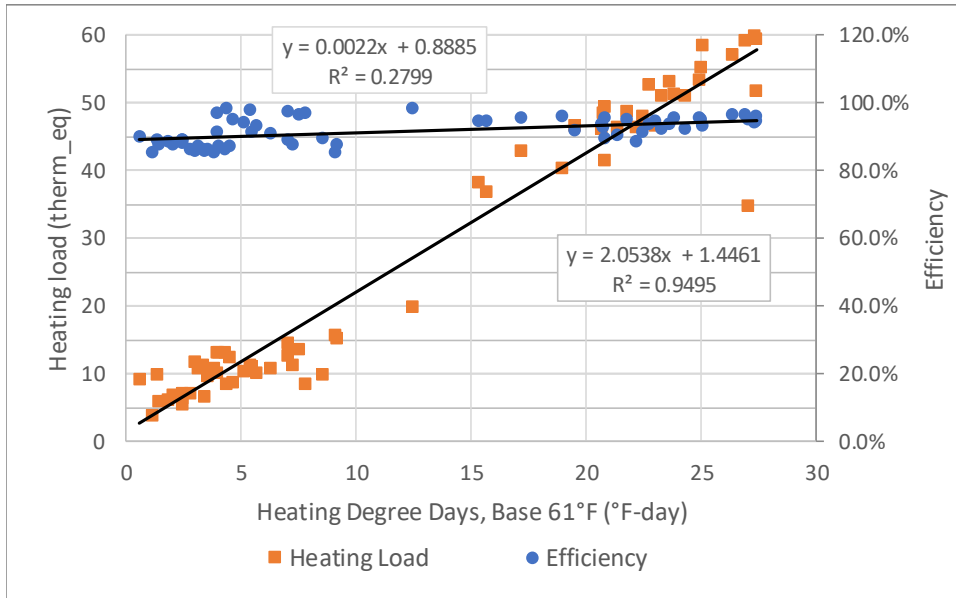
FIGURE 16 - SITE C DAILY HEATING LOAD & EFFICIENCY (2/14/19 - 5/31/19)

The Site C unit experienced issues with low inlet gas pressure and an out-of-tune burner from December 2018 through January 2019 (see Section 5.2 for more information). Due to these issues, we only include the heating load and efficiency weather regressions after 2/14/2019 in our annual performance calculations, which is the date Energy 350 and the site facilities manager tuned the burner. Figure 16 shows the equations used to annualize the gas consumption for Site C.

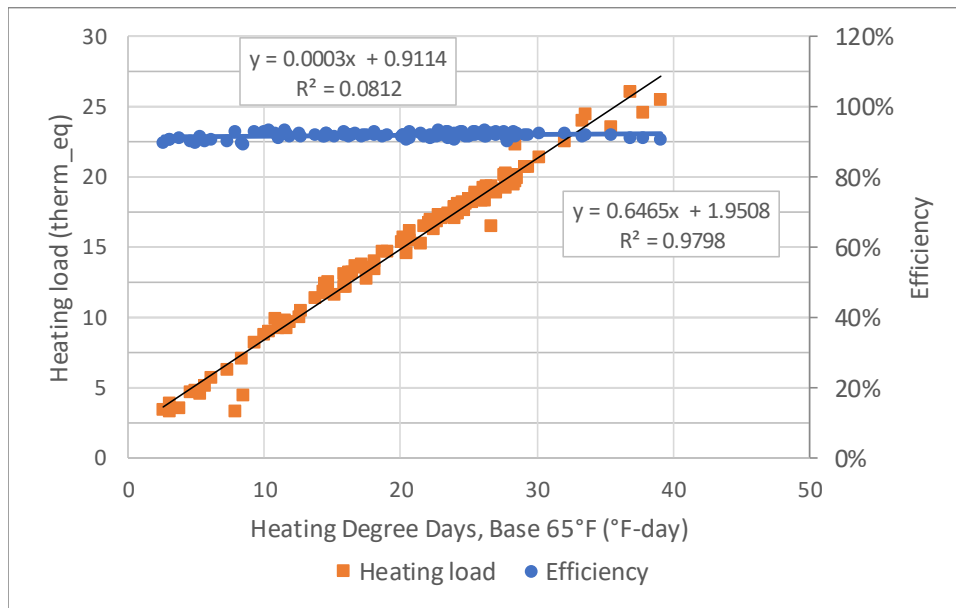
FIGURE 17 - SITE D DAILY HEATING LOAD & EFFICIENCY

Figure 17 shows the heating load and efficiency relationships with HDD for Site D. This unit operated consistently 24/7 throughout the 2018/2019 heating season at a constant discharge air temperature setpoint. As a result, the heating load and efficiency relationships with HDD are tightly correlated.

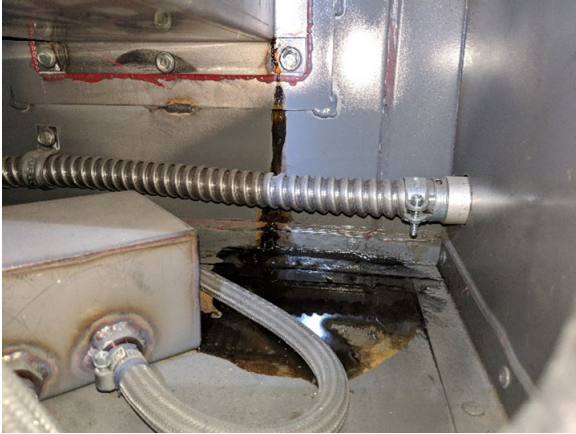
FIGURE 18 – SITE A FLUE BOX LEAK

During a morning equipment inspection, the Site A facility manager noticed a small pool of liquid developing inside the flue cabinet below the flue exhaust. Upon close inspection, he discovered a slow leak from the lower right corner of the box where combustion gases exit the heat exchanger before being exhausted through the flue, as shown in Figure 18. A small amount of this condensate was also leaking around the condensate drain stub (pictured in Figure 19). After consulting ICE Western, Energy 350 removed the flue box to identify the issue and discovered a small gap in the welding joint (Figure 20). The facilities manager had his/her shop repair the weld, and we reattached the flue box and sealed all joints with high temperature sealant. No further issues have been discovered.

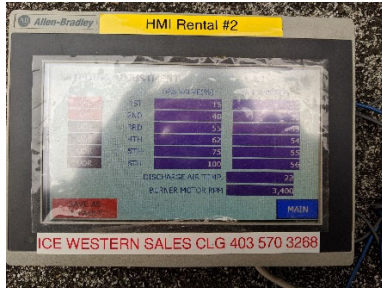
FIGURE 22 - HMI TOOL

Both ICE Western units required additional burner tuning after startup, which was only possible with a special HMI tool (Figure 22) that had to be shipped from the manufacturer. We were unaware of the need for this tool for the installation of the first ICE Western unit (Site A), and we elected not to have ICE Western send a technician from Calgary as the HMI tool was not included with the unit and was quite expensive. However, after the installing contractor's burner technician was sent to Site A to tune the burner, and was unable to do so with the tool, we hired an ICE Western technician to fly down with the HMI tool and tune the burner.

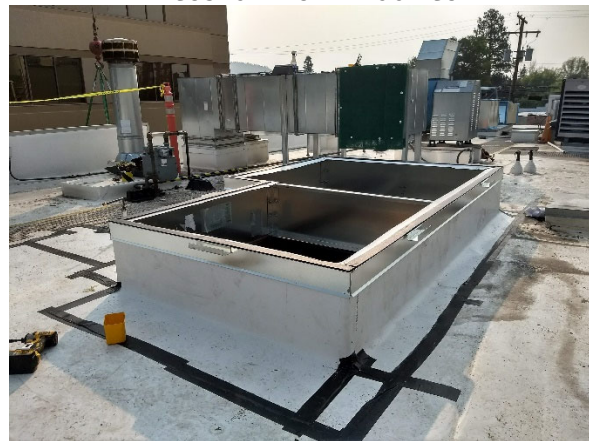
NEW CUSTOM-BUILT ROOF CURB

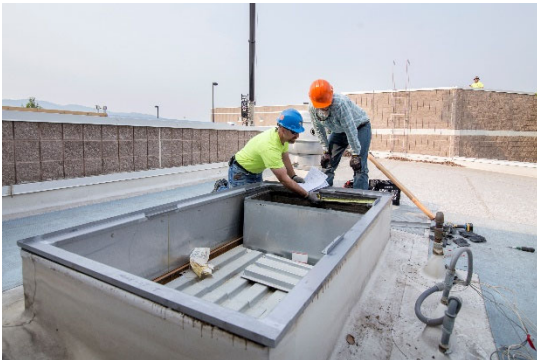
UTILIZING EXISTING ROOF CURB WITH CURB ADAPTER

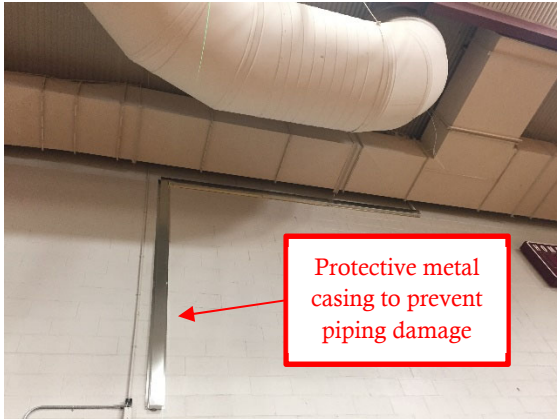
DRAIN PIPING WITH PROTECTIVE CASING

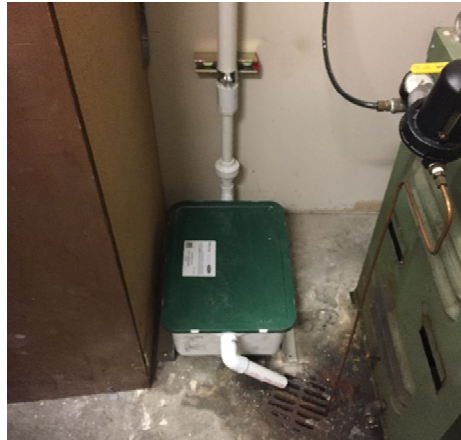
CONDENSATE NEUTRALIZER INSTALLED

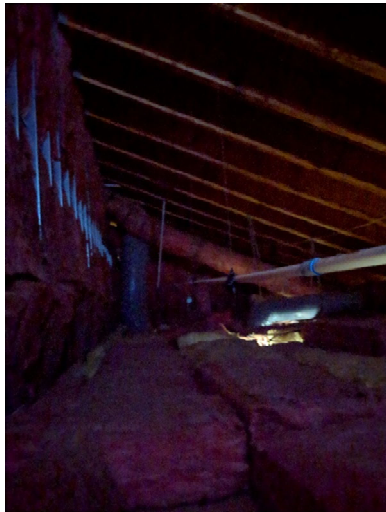
CONDENSATE DRAIN RUN IN ATTIC

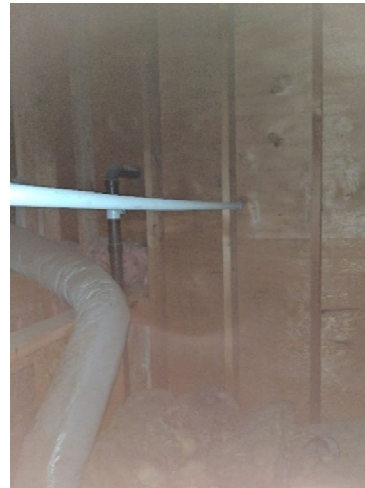
UNNEUTRALIZED CONDENSATE PENETRATION IN TOILET VENT PIPE

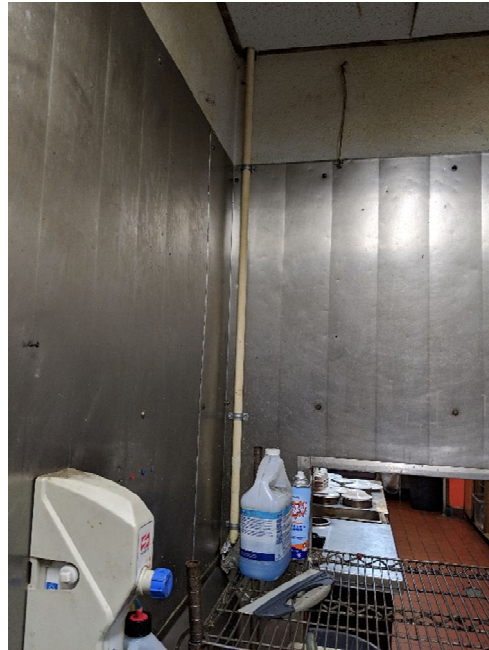
CONDENSATE LINE TERMINATING IN KITCHEN SINK

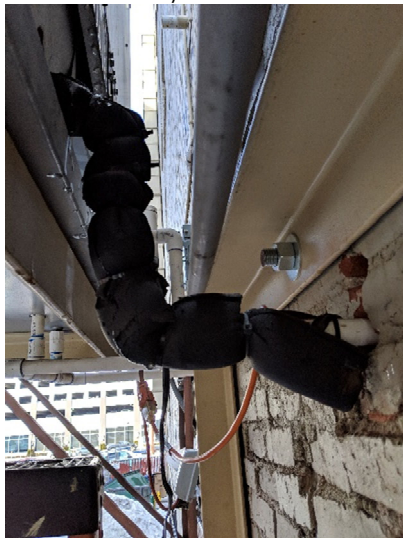
HEAT TRACE AROUND CONDENSATE LINE BETWEEN UNIT/BUILDING

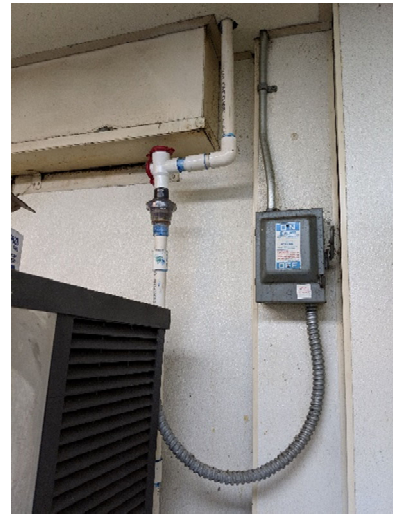
CONDENSATE LINE IN KITCHEN WITH WINDOW FOR VERIFYING CONDENSATE FLOW
